Table of Contents

General Information

Property Address: *123USA Drive*
City: *Cleveland* State: *Ohio* Zip: *11111*
Contact Name: *Joe Usa*
Phone: *999-999-9999* Fax:

Inspector Name: *Paul Wancata*
Company Name *Inspections Unlimited*
Company Address *1535 Lourdes Dr.*
City *Parma* State *OH* Zip *44134*
Phone: *216-571-1074* Fax *n/a*
E-Mail: *inspection sunlimited@cox.net*
File Number: *2010-200*
Amount Received: *\$275.00*

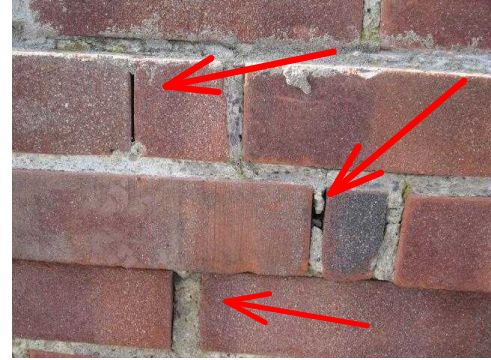
| 11. Chimney: <i>Brick</i> | <i>Marginal</i> |
| | <i>Chimney requires tuck point repairs by a mason specialist.</i> |

1. Main Chimney Chimney: *Brick Chimney requires tuck point repairs by a mason specialist.*

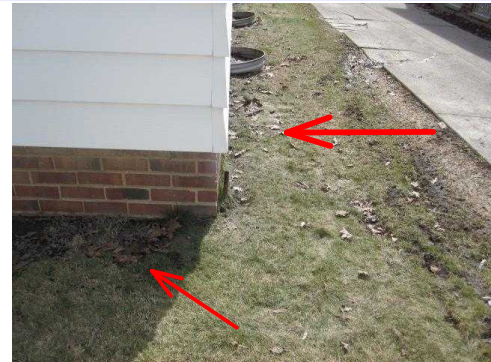
| 3. Grading: <i>Minor slope</i> | <i>Marginal</i> |
| | <i>Grading is sloped towards foundation which can cause moisture intrusion down foundation. Recommend evaluation and repair by a professional.</i> |

2. Grading: *Minor slope Grading is sloped towards foundation which can cause moisture intrusion down foundation. Recommend evaluation and repair by a professional.*

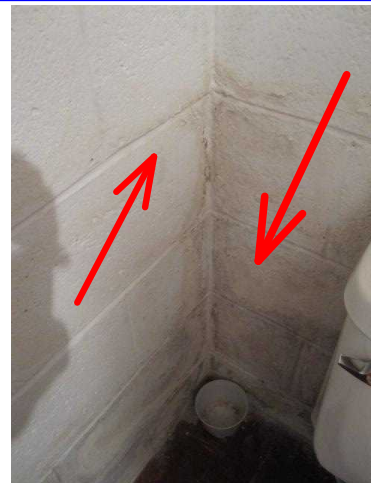
15. Moisture Location: *Northern half*

There is a small amount of moisture staining on north wall. This is the same area outside where there was negative grading discovered. Recommend re grading of northern landscaping. All basement walls may experience some sort of moisture. The goal is to keep all water run off away from foundation walls.

4. Main Basement Moisture Location: *Northern half There is a small amount of moisture staining on north wall. This is the same area outside where there was negative grading discovered. Recommend re grading of northern landscaping. All basement walls may experience some sort of moisture. The goal is to keep all water run off away from foundation walls.*

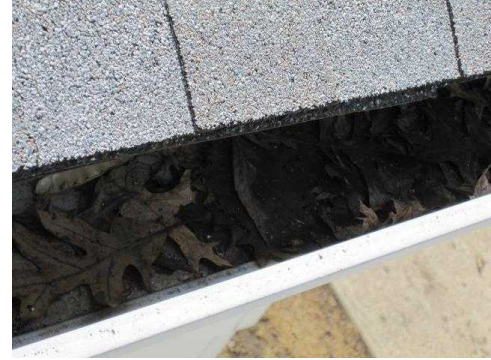
| 9. Gutters: <i>Aluminum</i> | <i>Repair / Replace</i> |
| | <i>Gutters are dirty and filled with debris which can cause overflow of gutters and send water down foundation wall. Recommend cleaning by a roofing specialist.</i> |

1. Gutters: *Aluminum Gutters are dirty and filled with debris which can cause overflow of gutters and send water down foundation wall. Recommend cleaning by a roofing specialist.*

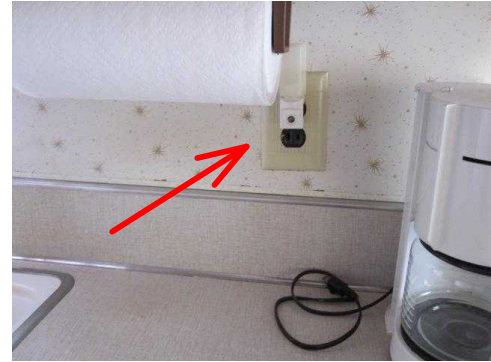
| 6. Electrical: <i>Lighting circuit, 110 receptacles</i> | <i>Repair / Replace</i> |
| | <i>GFCI-All kitchen or bathroom receptacles within 6' of water should be a GFCI receptacle or on a GFCI circuit. Recommend evaluation and repair by a licensed electrician.</i> |

2. 1st Floor Kitchen Electrical: *Lighting circuit, 110 receptacles GFCI-All kitchen or bathroom receptacles within 6' of water should be a GFCI receptacle or on a GFCI circuit. Recommend evaluation and repair by a licensed electrician.*

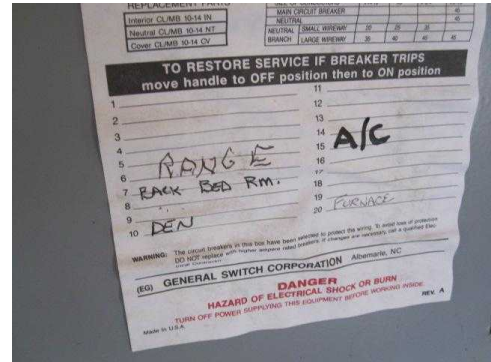
| 12. Panel Labeled? <i>No</i> | <i>Repair / Replace</i>

<i>All electrical panels should be properly labeled. Recommend proper labeling.</i> |

5. Basement Electric Panel Panel Labeled? *No All electrical panels should be properly labeled. Recommend proper labeling.*

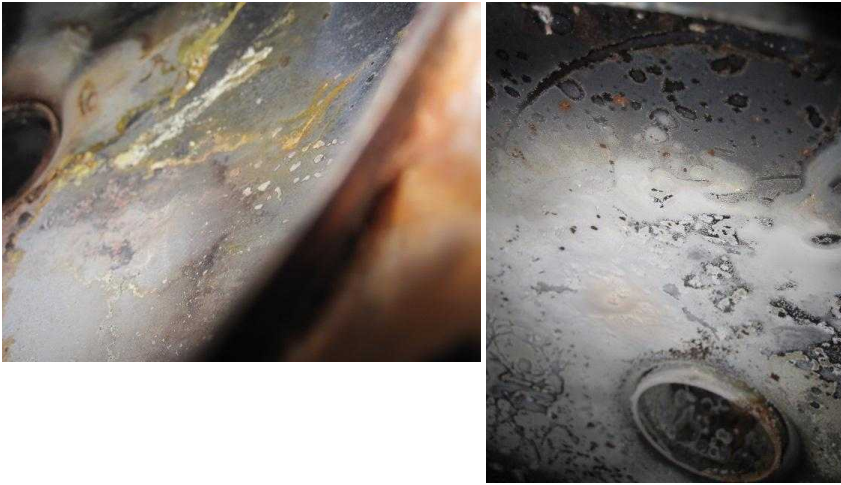
Water Heater Operation: (continued)

Repair / Replace

Unit functional at time of inspection, but is functioning beyond designed life expectancy and should be budgeted for replacement. The unit is rusted and pitted in the burner area.

6. Basement Water Heater Water Heater Operation: *Functional Unit functional at time of inspection, but is functioning beyond designed life expectancy and should be budgeted for replacement. The unit is rusted and pitted in the burner area.*
